NRL/MR/6180--05-8928

General Atomics Smart Microsensors — FY05 Shipboard Fire Test Results

GENERAL ATOMICS SMART MICROSENSORS – FY05 SHIPBOARD FIRE TEST RESULTS

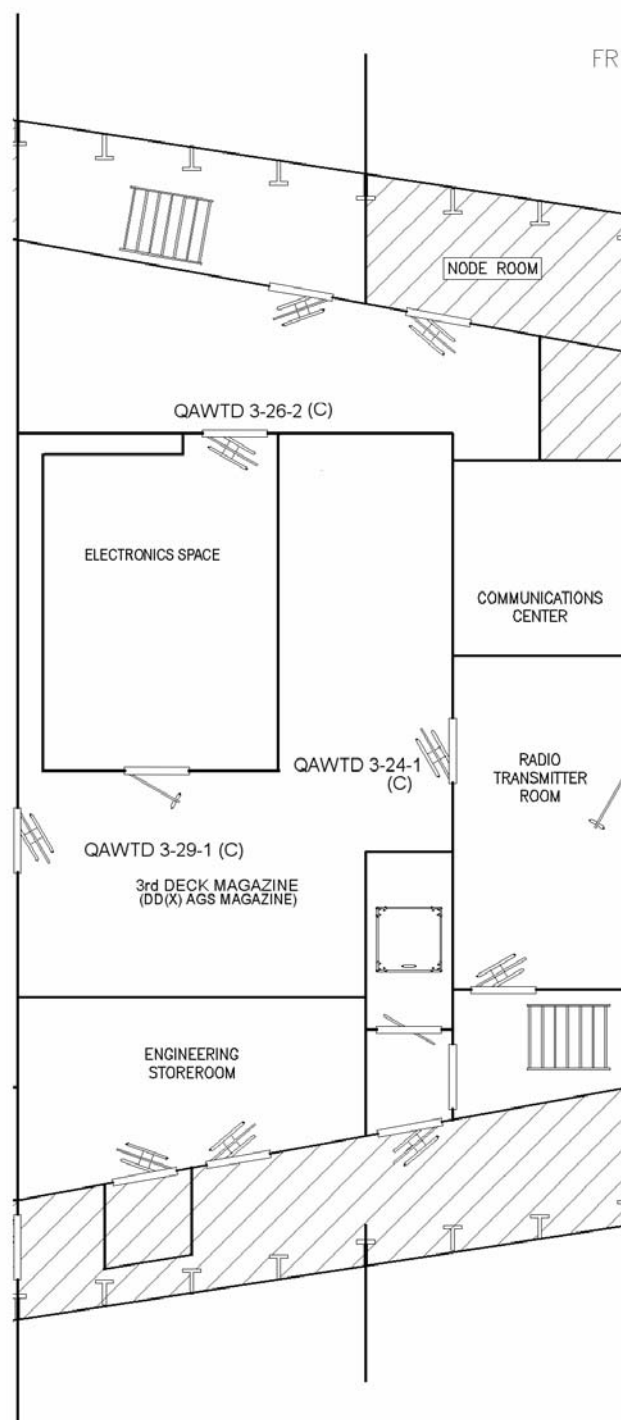
Fig. 1 — Layout of the spaces in the vicinity of the 3rd deck magazine

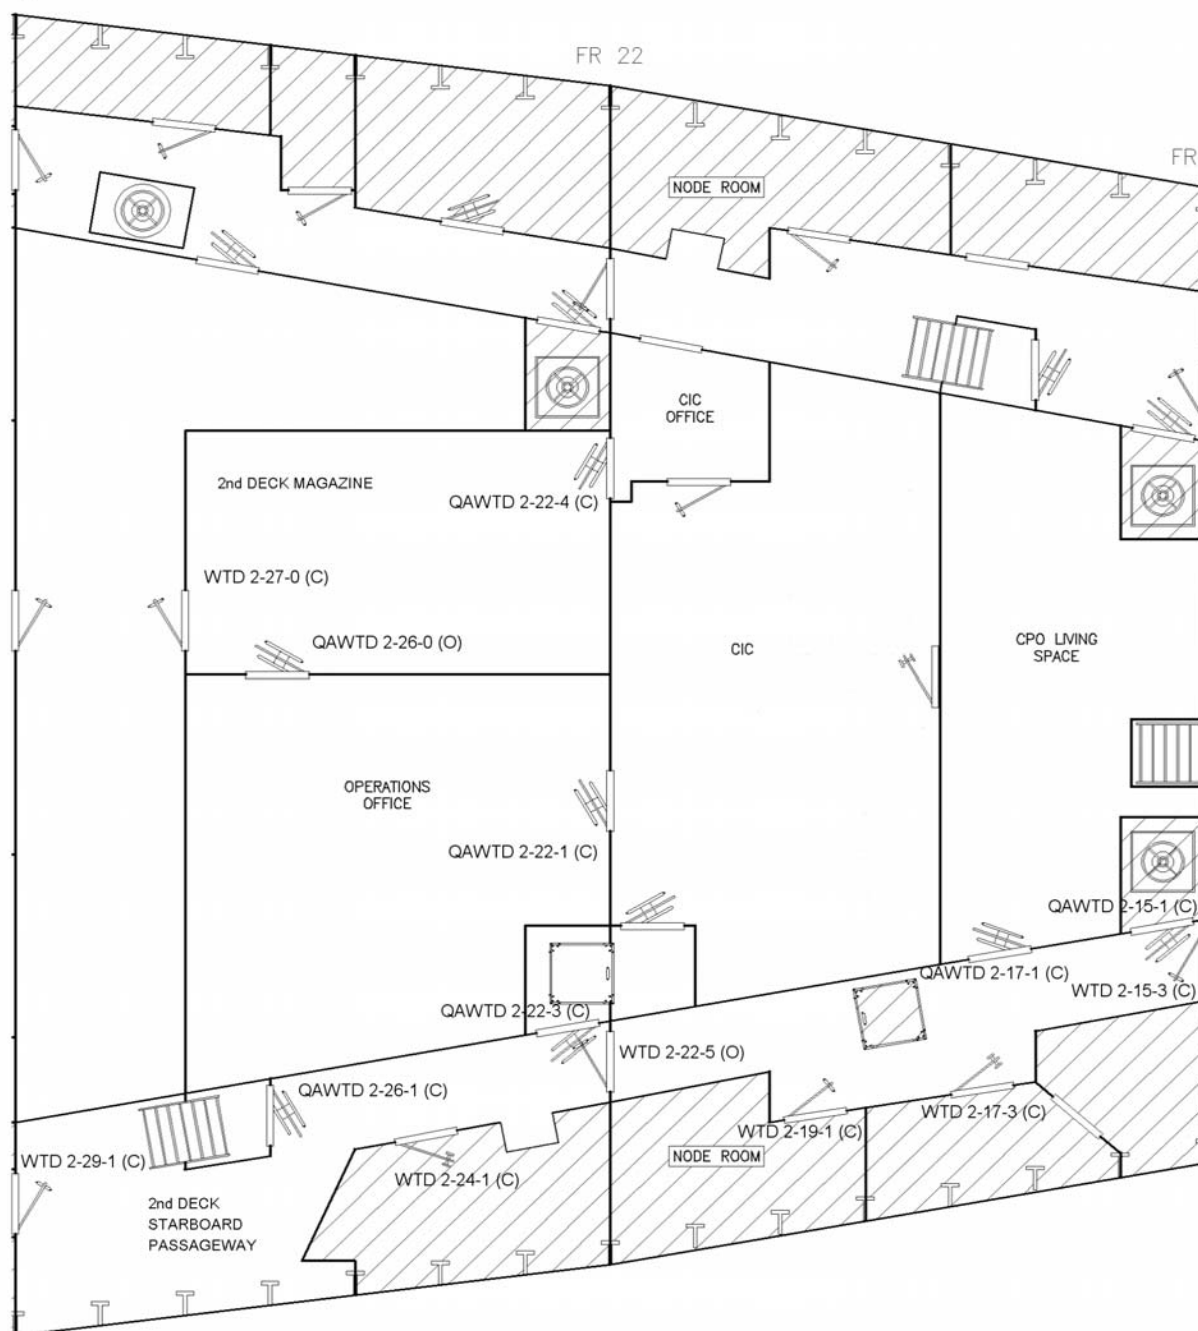
Fig. 2 — Layout of the spaces on the 2nd deck

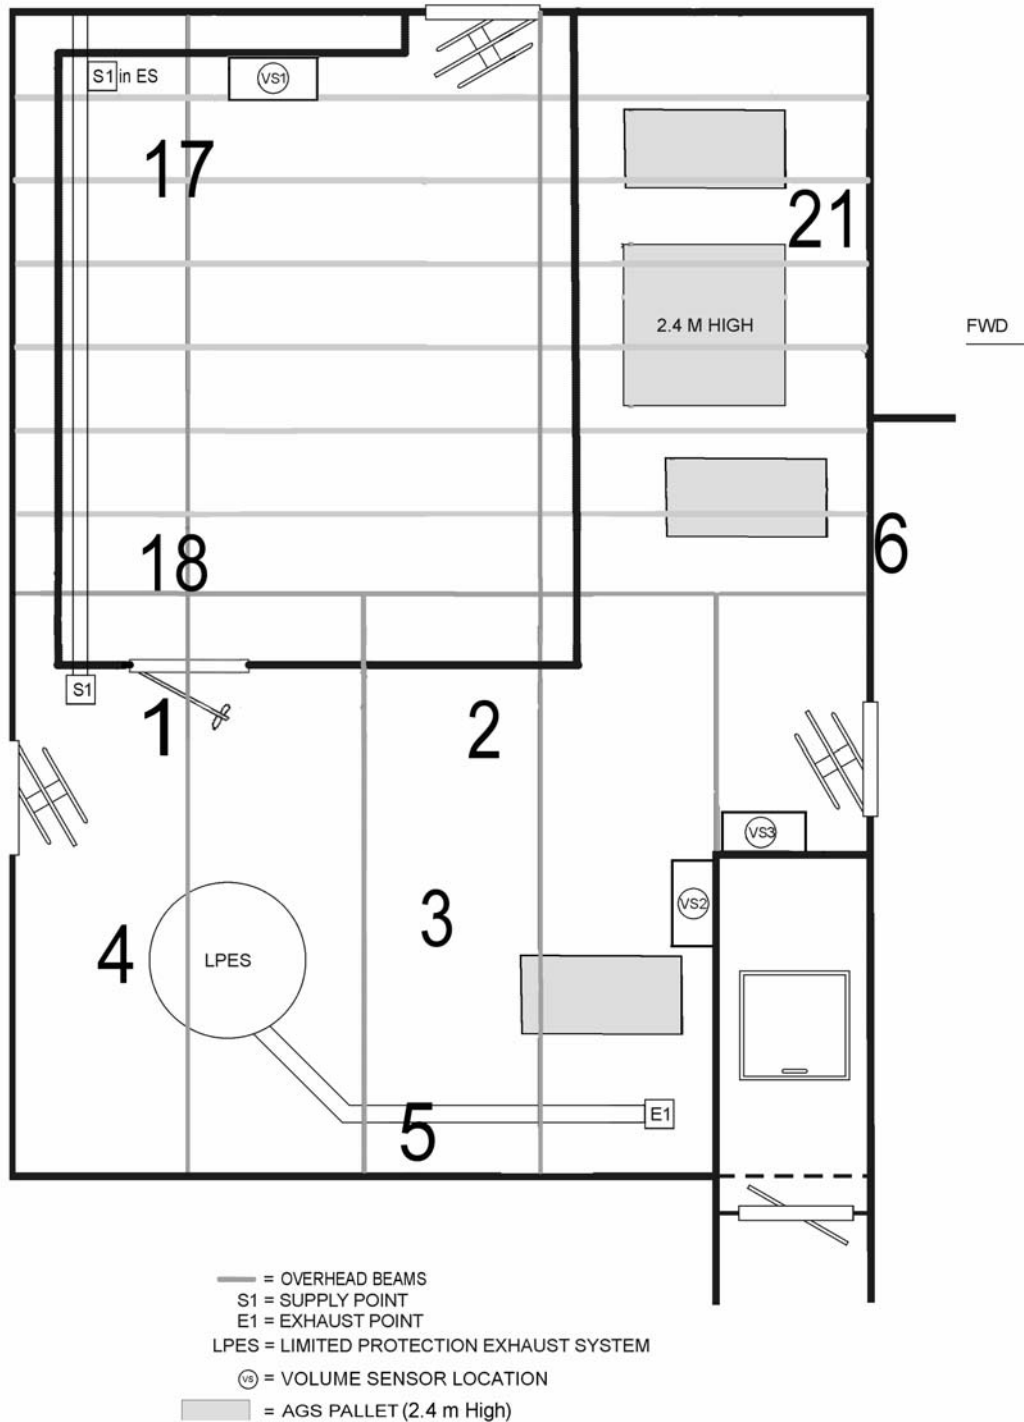
Fig. 3 — Layout of deck obstructions and source locations within 3rd deck magazine

In addition to the overhead beams, light fixtures, and a partial overhead grid in the 3rd deck magazine, obstructions, in the form of mock AGS pallets, were located on the deck within the compartment. The mock pallets were approximately 2.4 m (8.0 ft) in height 1.22 m (4.0 ft) wide and varied from 0.61 to 1.22 m (2 ft to 4 ft) in length. Figure 3 shows the layout of the mock AGS pallets and source locations within the 3rd deck magazine.

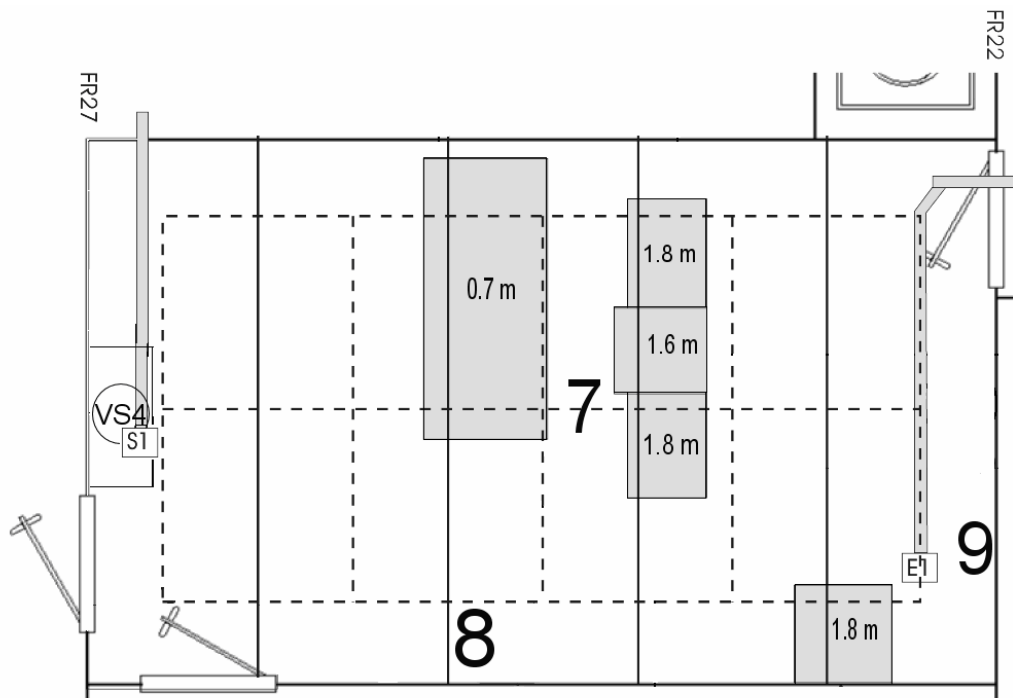
Fig. 4 — Layout of deck obstructions and source locations within 2nd deck magazine

In addition to the light fixtures, overhead (OH) beams, and the OH grid, cabinets were placed on the deck within the compartment. The cabinets varied in height (Fig 4) and were dispersed throughout the compartment. Figure 4 shows the source locations and layout of the cabinets within the 2nd deck magazine, the layout is similar to the layout used in CVN 21 Fire Threat to Ordnance [11].

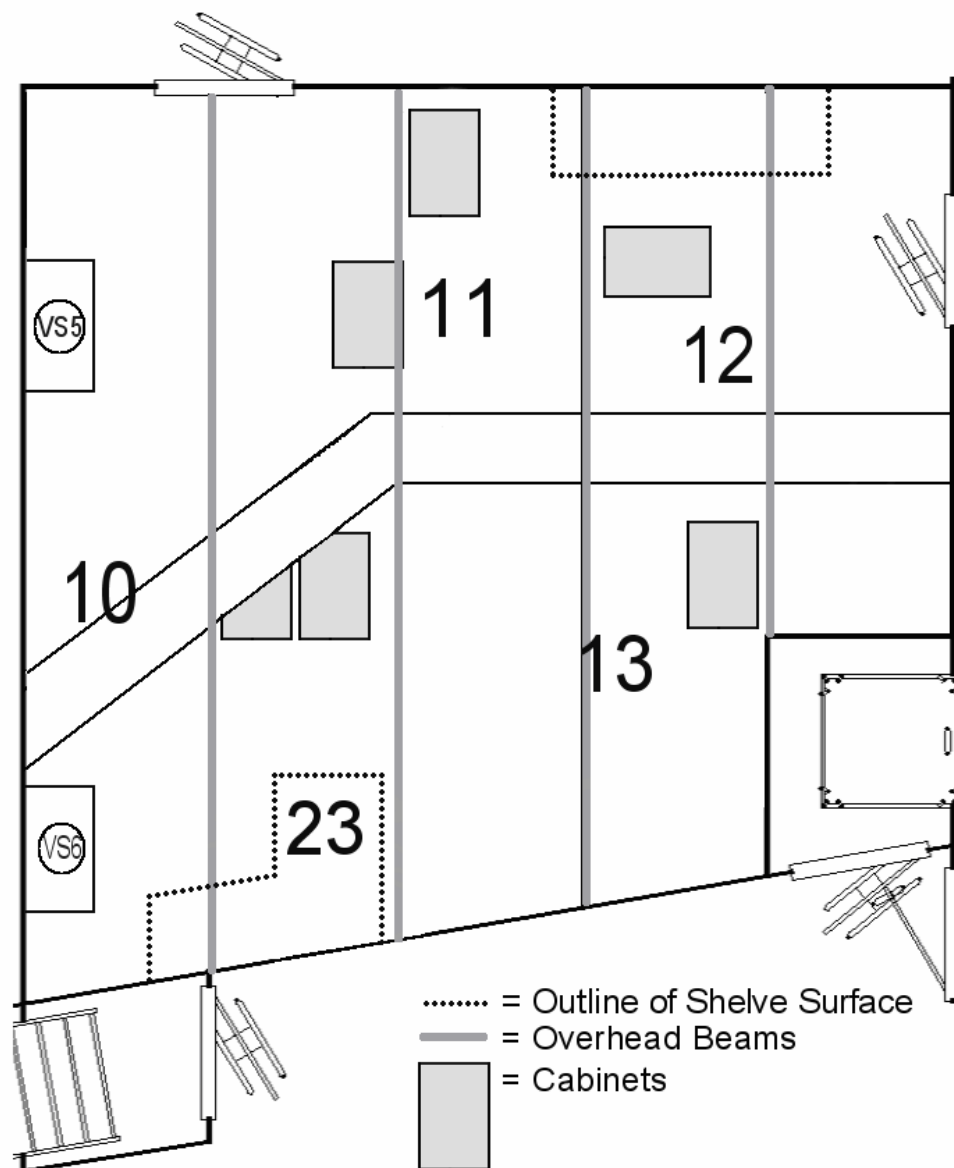
Fig. 5 — Layout of deck obstructions and source locations within 2nd deck operations office

Obstructions, in the form of cabinets, were placed in the operations office. The cabinets were dispersed throughout the compartment. Figure 5 shows the ventilation duct, source locations, and the layout of the cabinets within the 2nd deck operations office. Figure 6 shows the ventilation duct, source locations, and the layout of the cabinets adjusted to accommodate source location 22 within the 2nd deck operations office (tests VS5_35 – VS5_39).

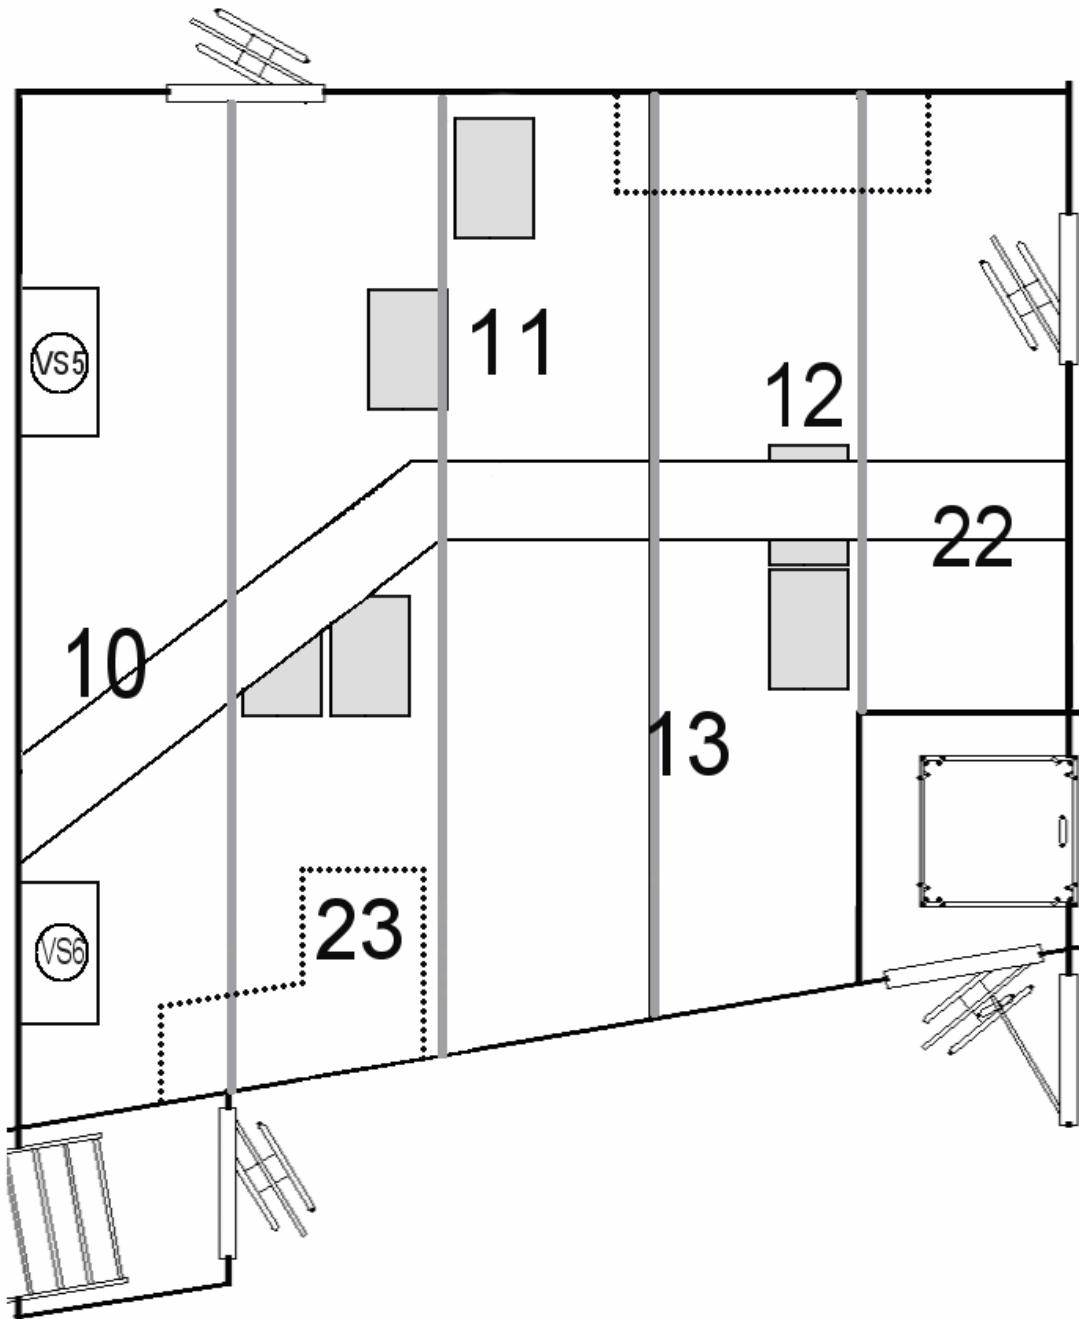
Fig. 6 — Layout of deck obstructions and source locations within 2nd deck operations office incorporating source location 22.

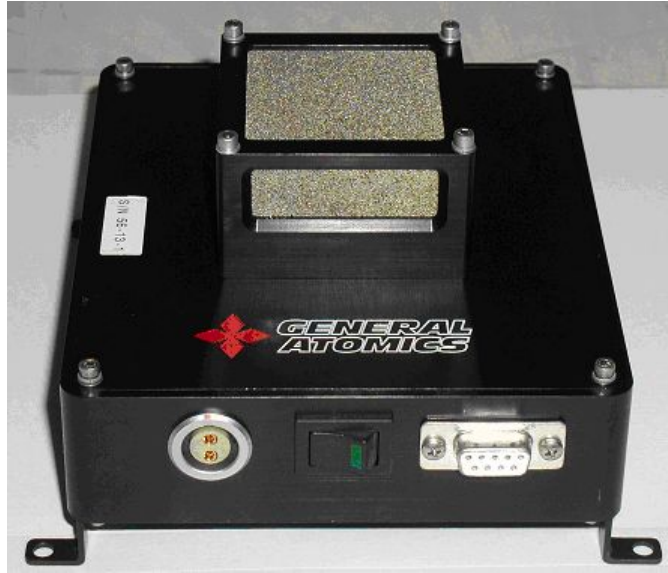
Fig. 8 – GA Smart Microsensor Prototype.

The GA microsensor prototype, shown in Fig. 8, is composed of a physical sensing system, graphical user interface software, and a 24 VDC power supply. The physical sensing system involves a microsensor array of economical, durable, high-temperature ceramic-metallic (cermet) sensor elements, shown in Fig. 9. An electrochemical (voltammetric) measurement technique was used to generate the complex response waveform from the microsensors. Voltammetry involves applying a varying potential (typically a triangular waveform) across an electrochemical cell and measuring the resultant current. The electrical characteristics of an electrochemical cell (i.e. current vs. voltage response) are influenced by the presence of analyte gases.

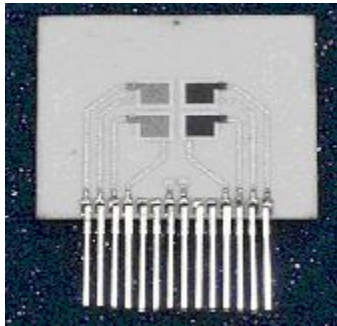
Fig. 9 – GA Chemical Microsensor Array.

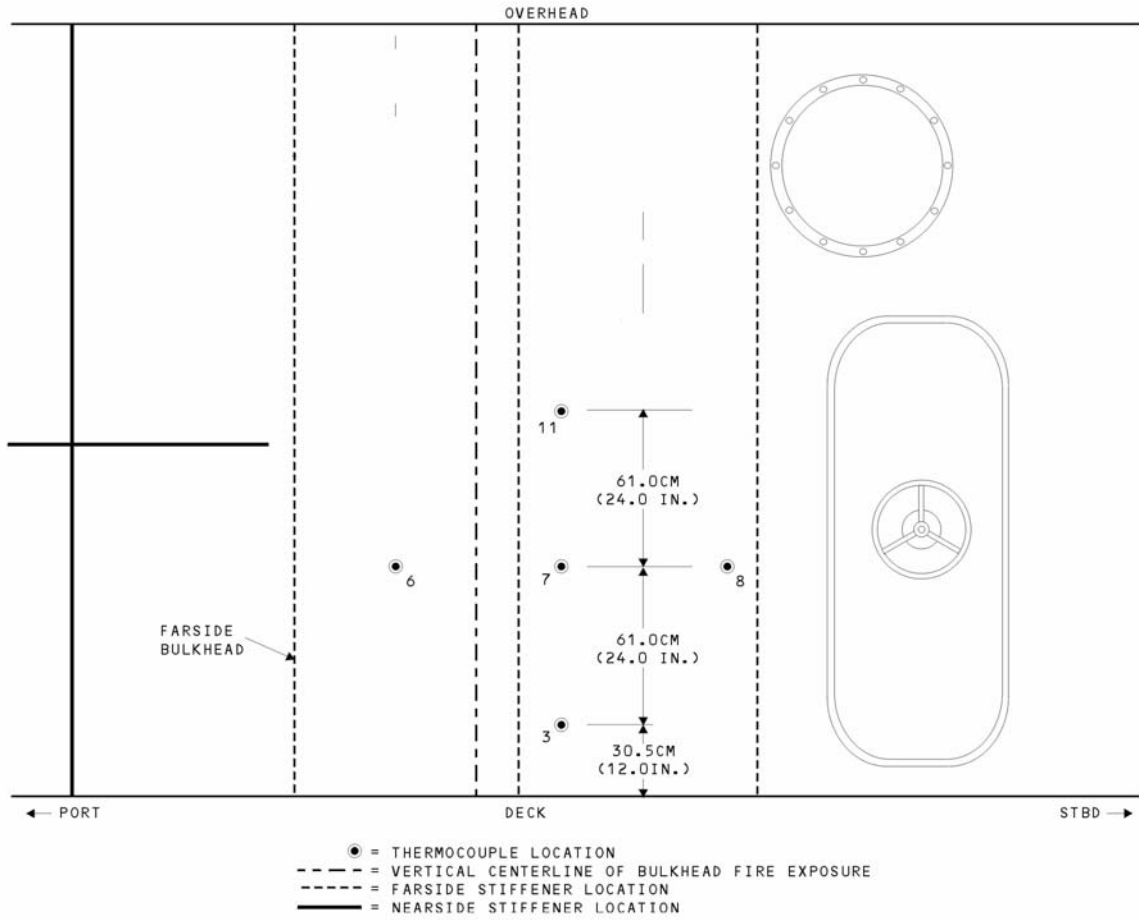
Fig. 11 — Locations of 3rd deck magazine forward bulkhead thermocouples

show the locations of the TCs, ODMs and detectors on the 3rd deck. The TC, ODM, and detector locations on the 2nd deck are detailed in Fig. 12.

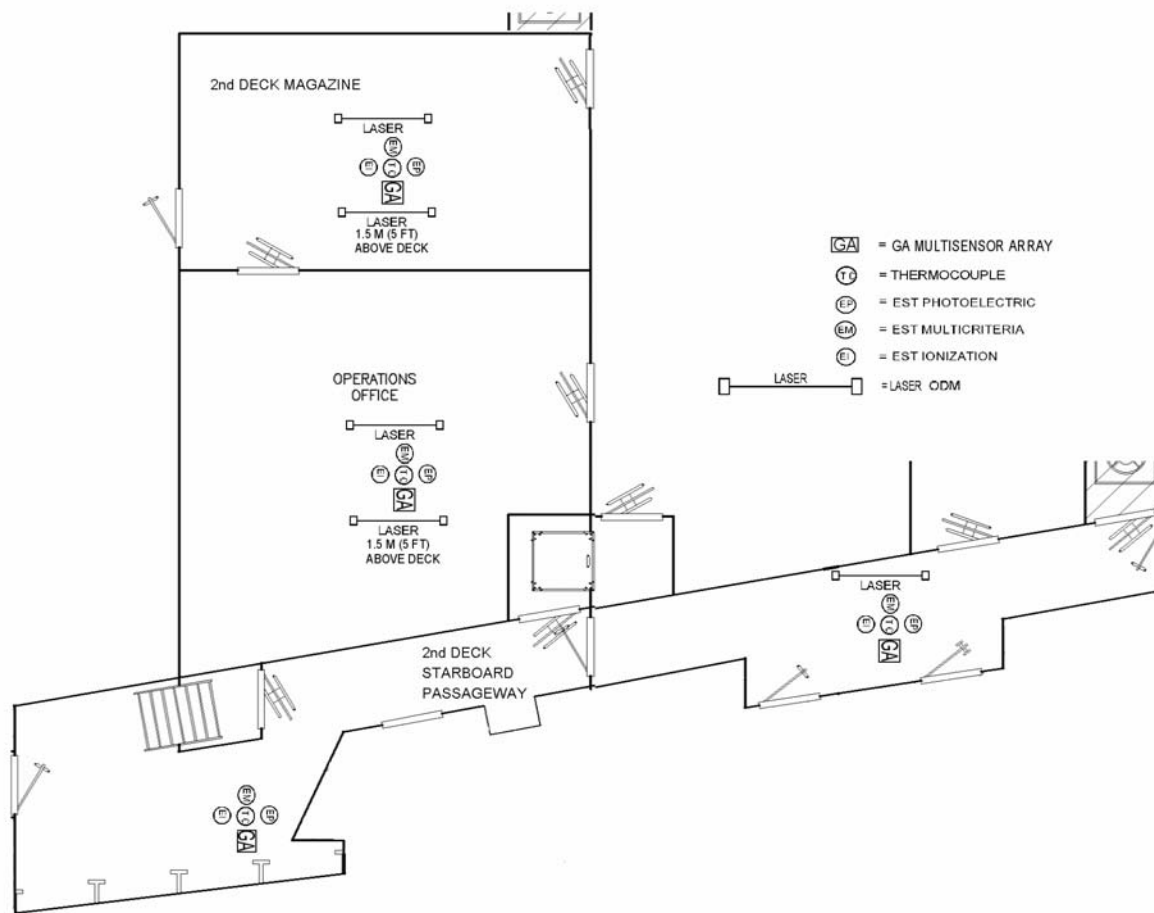
Fig. 12 — Locations of the GA sensor arrays, ODMs and spot-type detectors in 2nd deck test compartments
